Residential \* Sales \* Service \* Installation \* Commercial \* Maintenance

## Sample Advanced HVAC Report

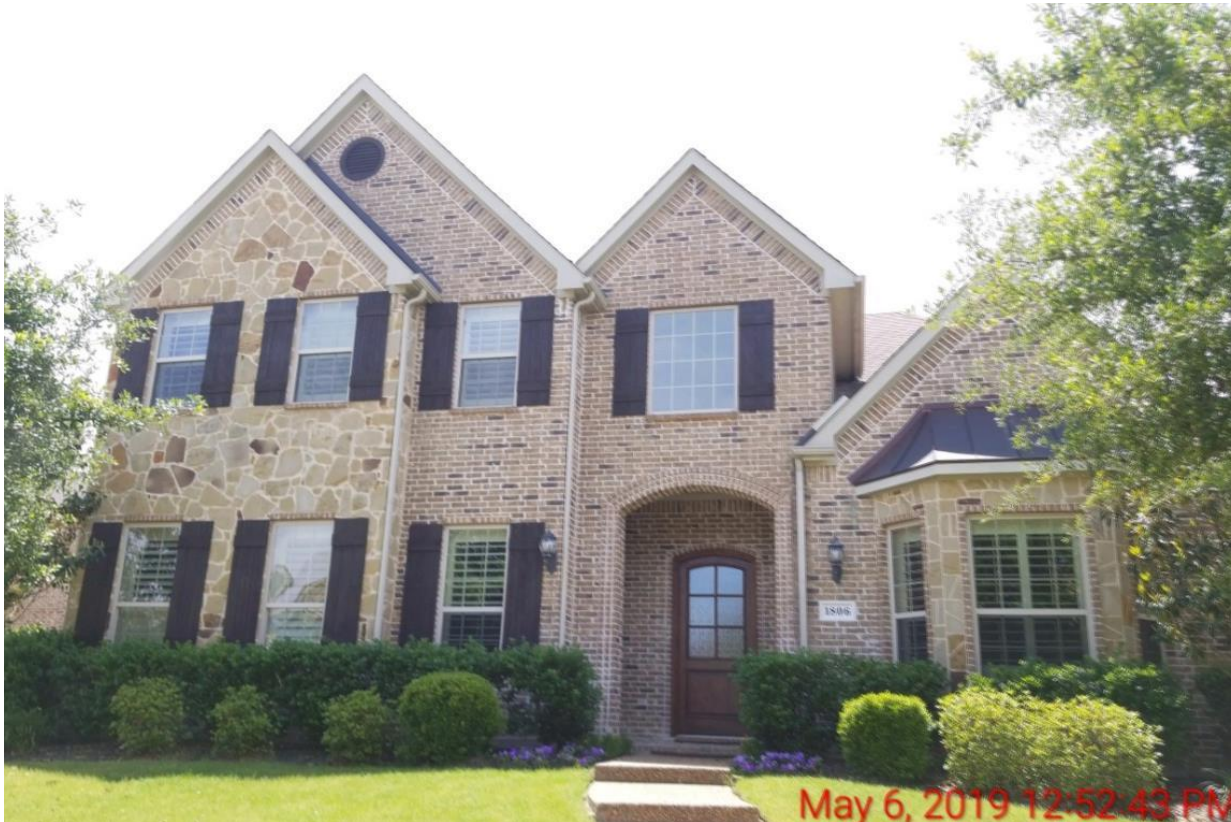
May 6, 2019  
Luxe Air, LLC  
1638 Vicky Ln.  
Grand Prairie, TX 75052  
469-777-4883  
[www.luxeairtexas.com](http://www.luxeairtexas.com)

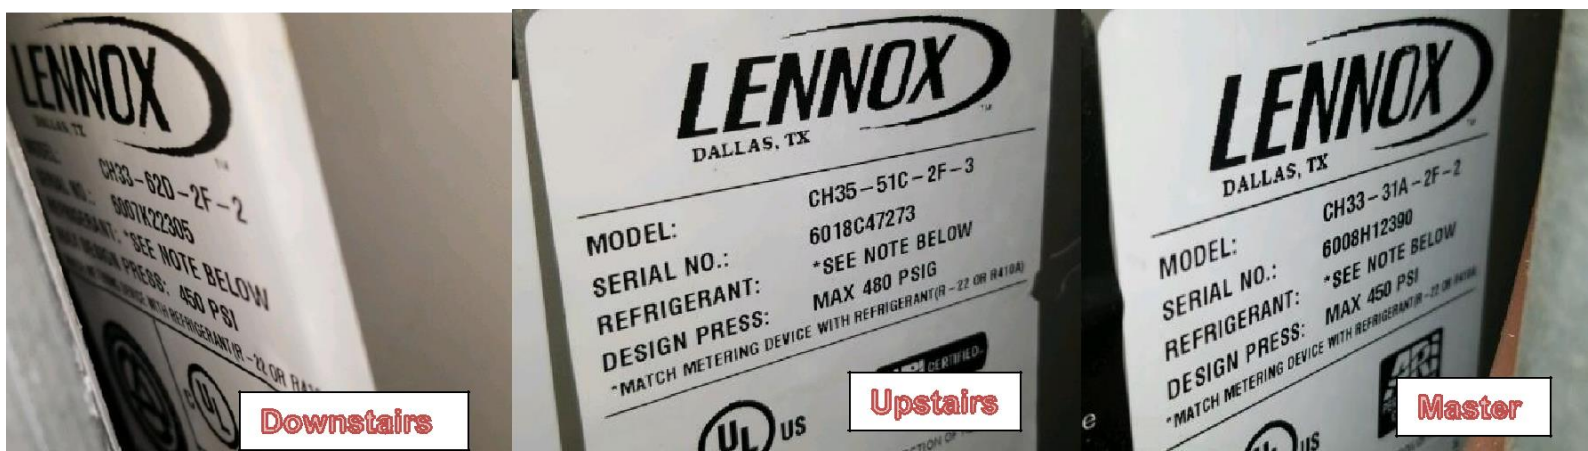
## Furnace nameplate:

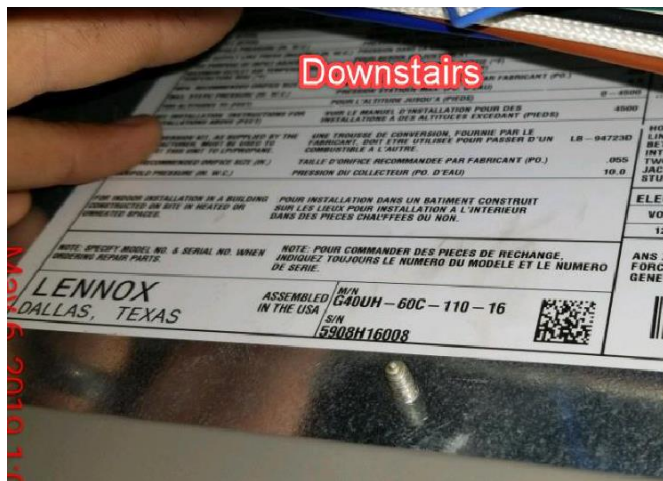
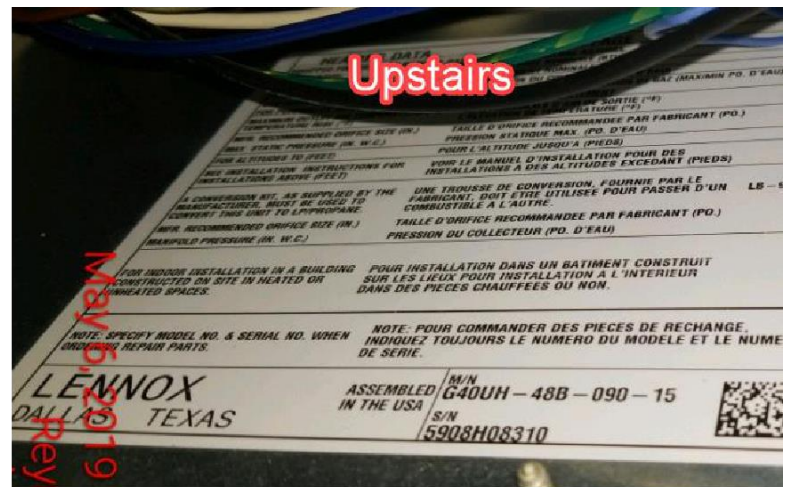
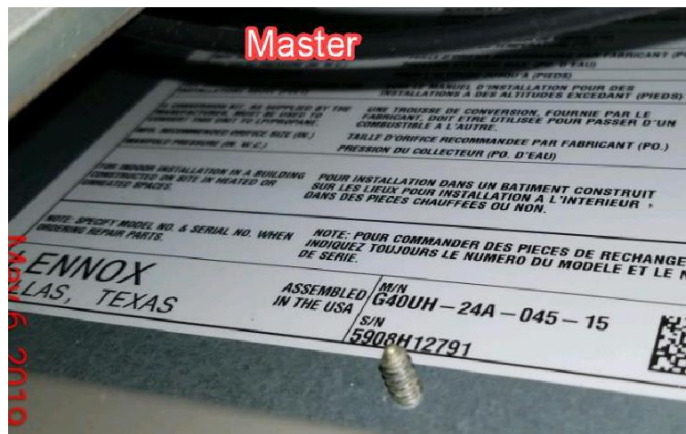
## Operating pressures:

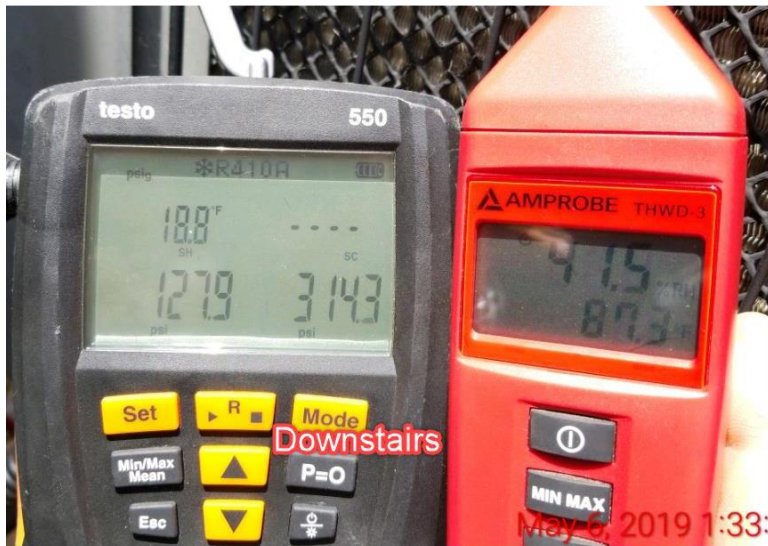
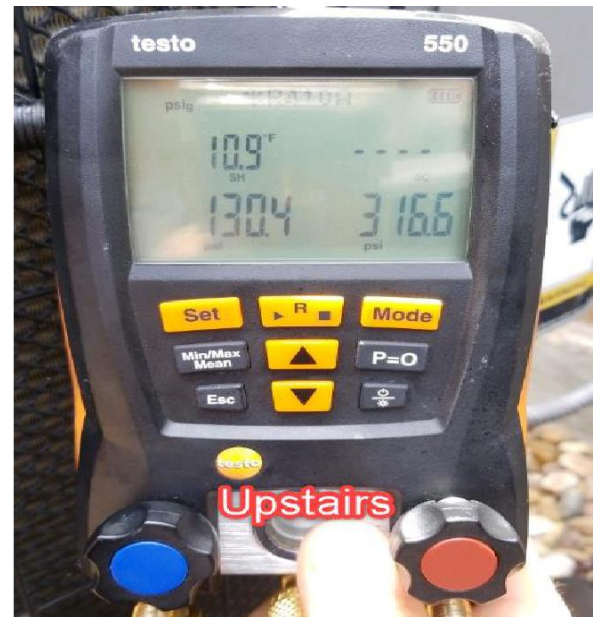
- ☒ Pressures were too high – Master bedroom unit

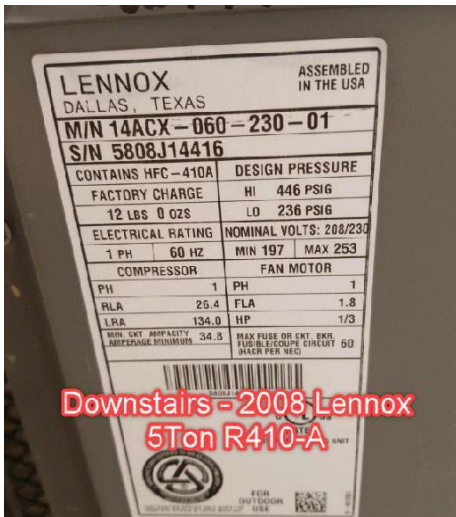
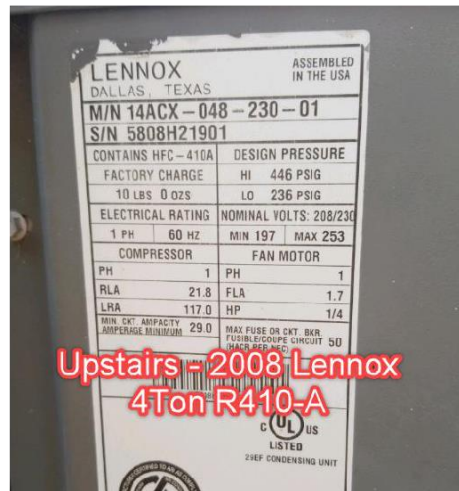
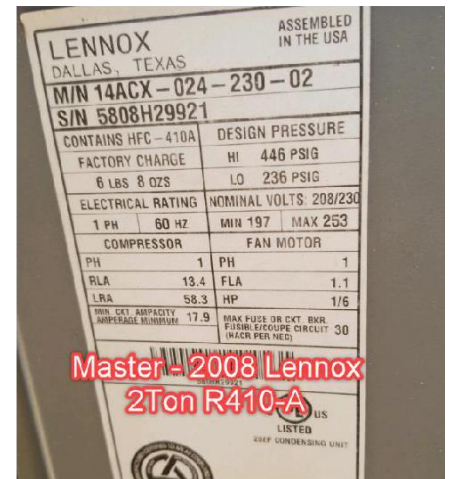
### Fan blade hub condition:

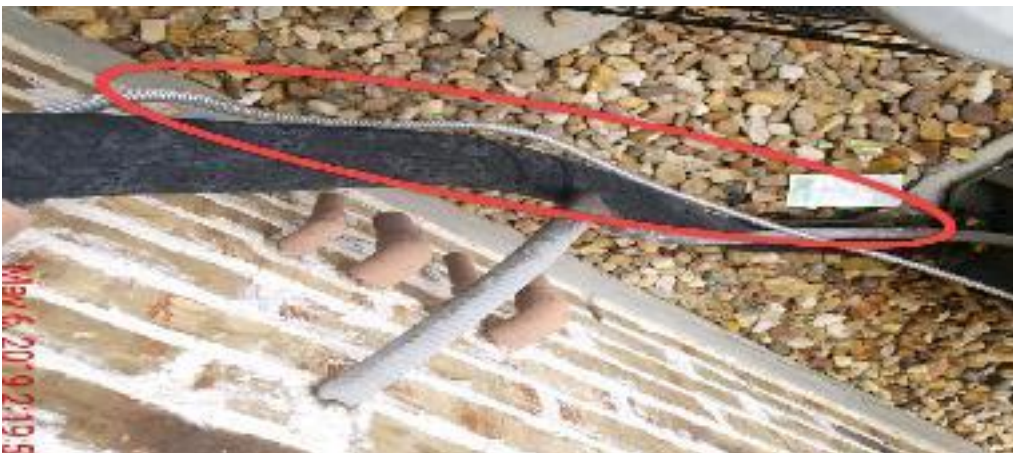
### Condition of outdoor condenser(s):

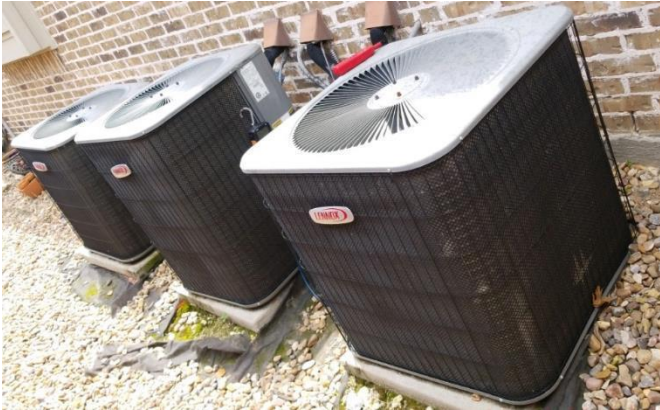
### Capacitor condition:

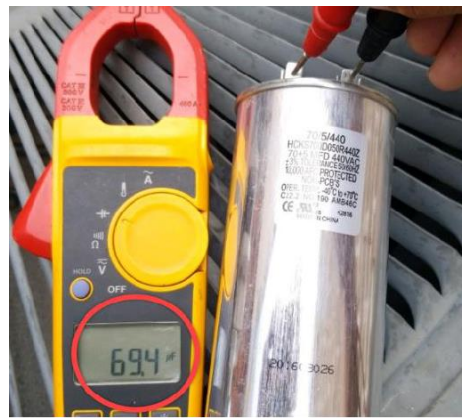
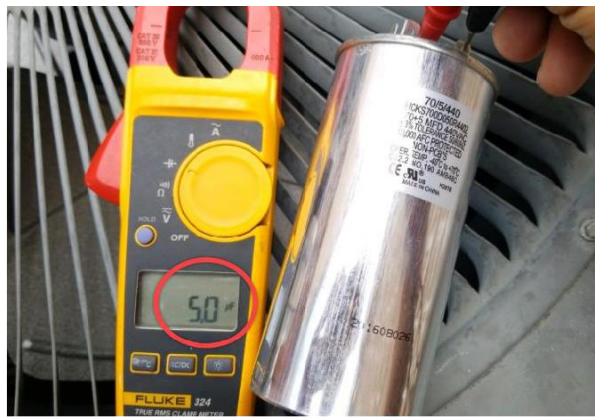
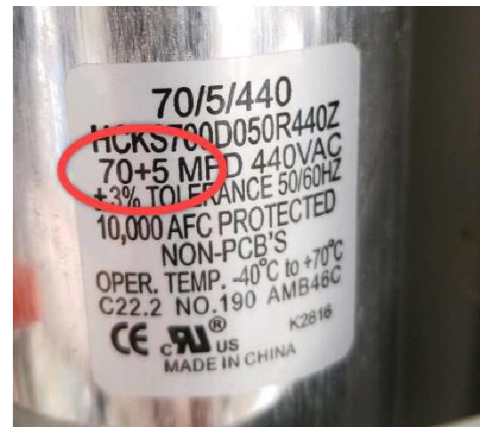
### Emergency drain pan condition:

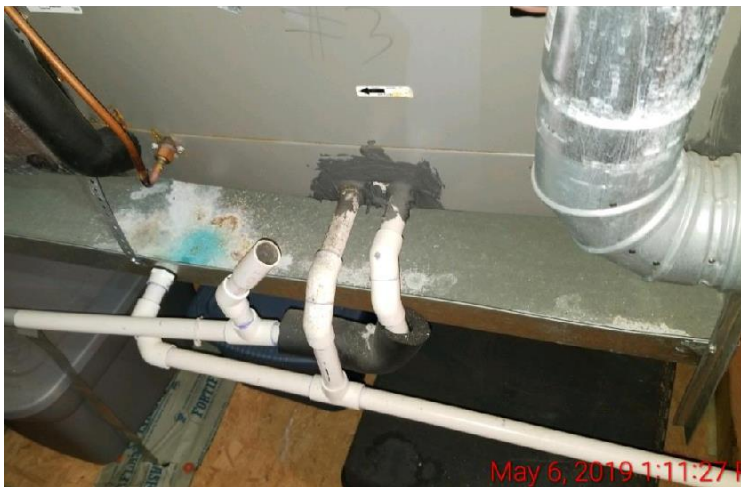
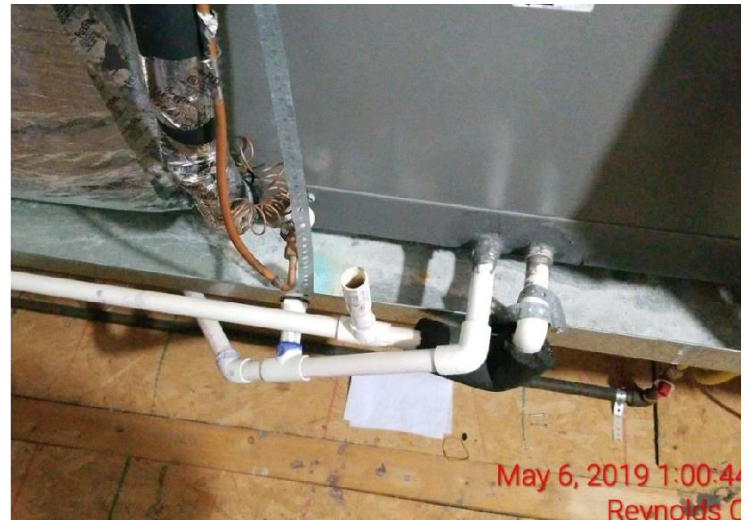
☒ Rust observed – Upstairs unit

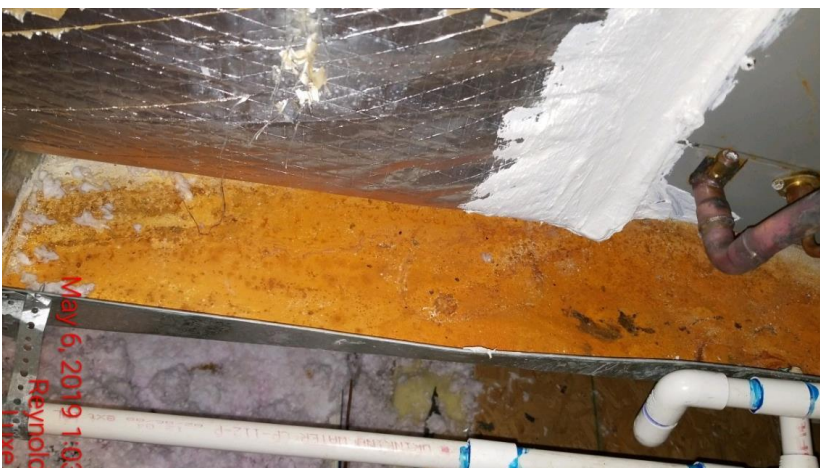
### Condition of heating flue pipe

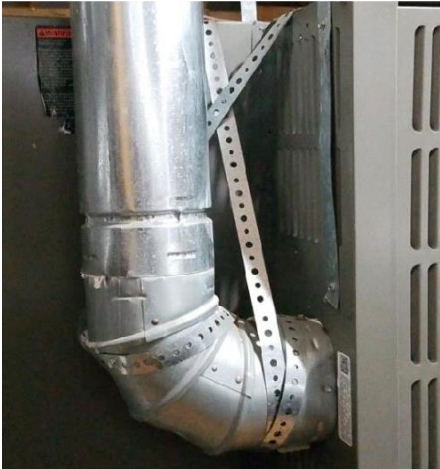
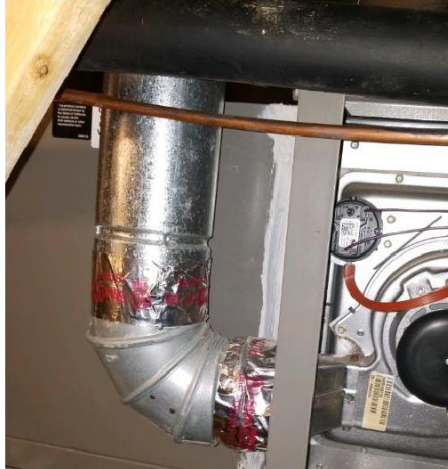
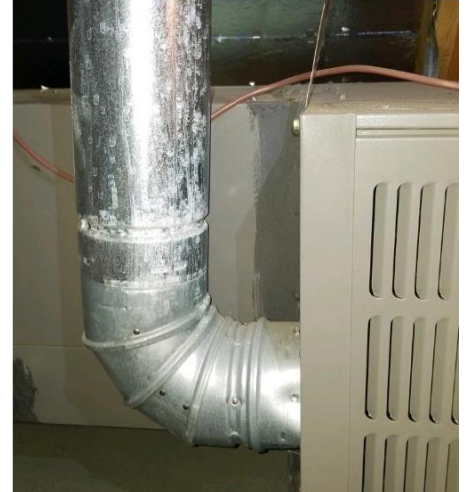
### Duct work condition:

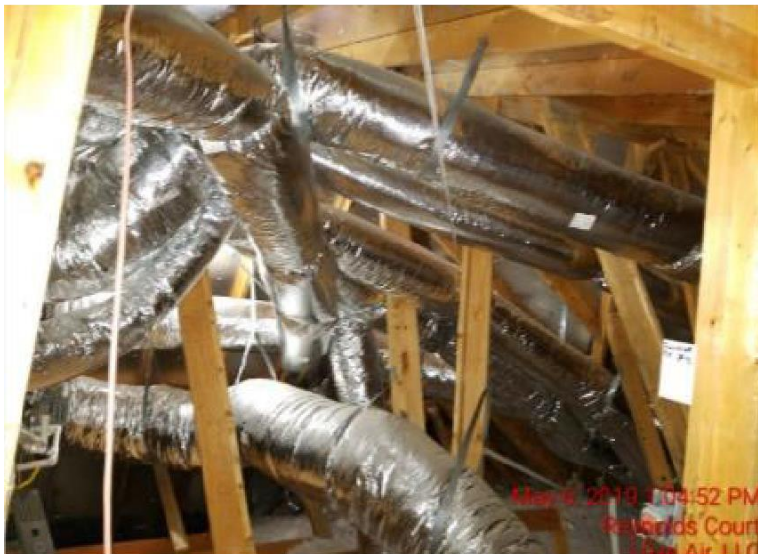
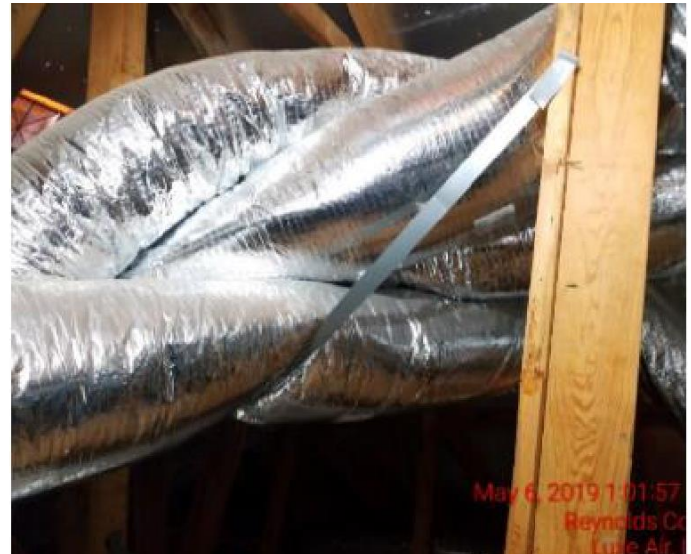
## Thermostat condition:

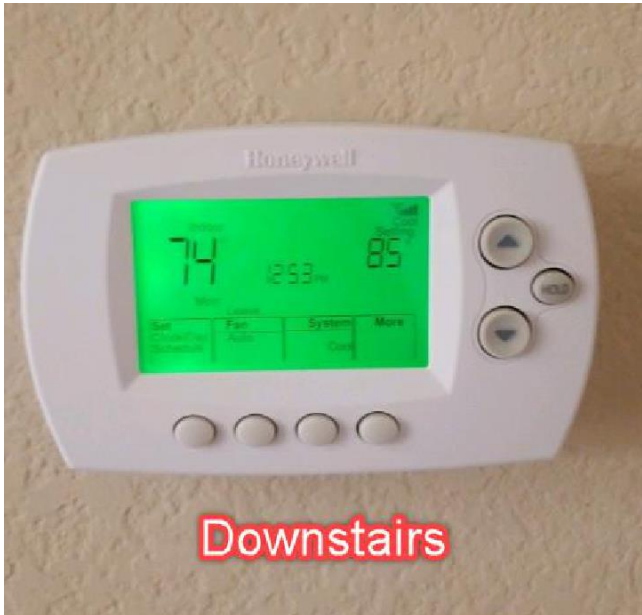
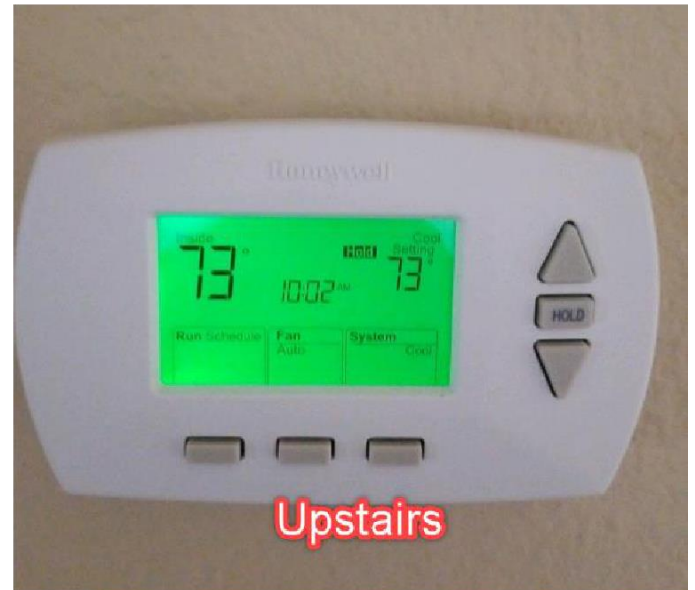
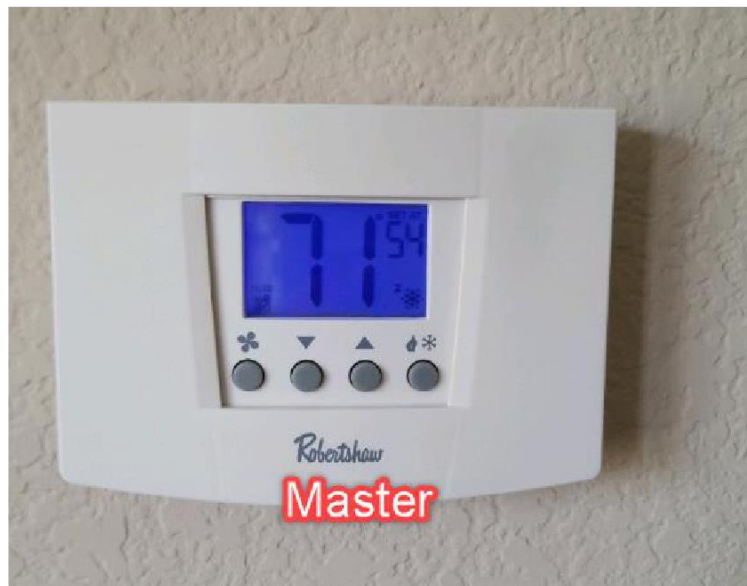
- ☒ Thermostat is operating normally
